NRL Report 8139

6
**The Refrigeration-11 Plant—
An Evaluation of Residue Formation and
Chemical Cleaning Methods**

Chemistry Division

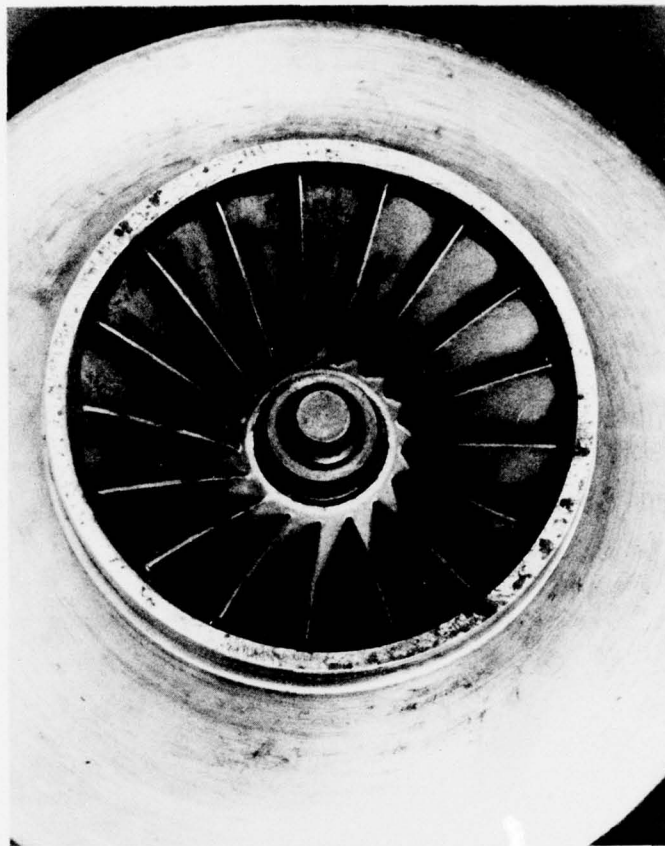
An impeller (Fig. 1) from an R-11 plant showed alternate layers of red and gray deposits, indicating possible formation of FeO, Fe₂O₃, and Fe₃O₄. A heterogeneous rusty brown residue was obtained by physically scraping the deposits from various parts of the R-11 plant (Fig. 2).

Fig. 1 — Impeller with buildup of solid residue

Analysis by emission spectroscopy (Table 1) showed that the scrapings from the void space walls in the plant were mainly iron, whereas scrapings from the general plant area and the impeller contained, in addition to iron, significant quantities of aluminum and copper. Further, an elemental analysis of the scrapings from the general plant area for carbon, nitrogen, hydrogen, and residue contents indicated a percentage composition of 3.5, 0.3, 1.1, and 83.3, respectively.

3. Analysis of the residue and the deposits on an R-11 plant impeller indicated high concentrations of aluminum, copper, and iron.

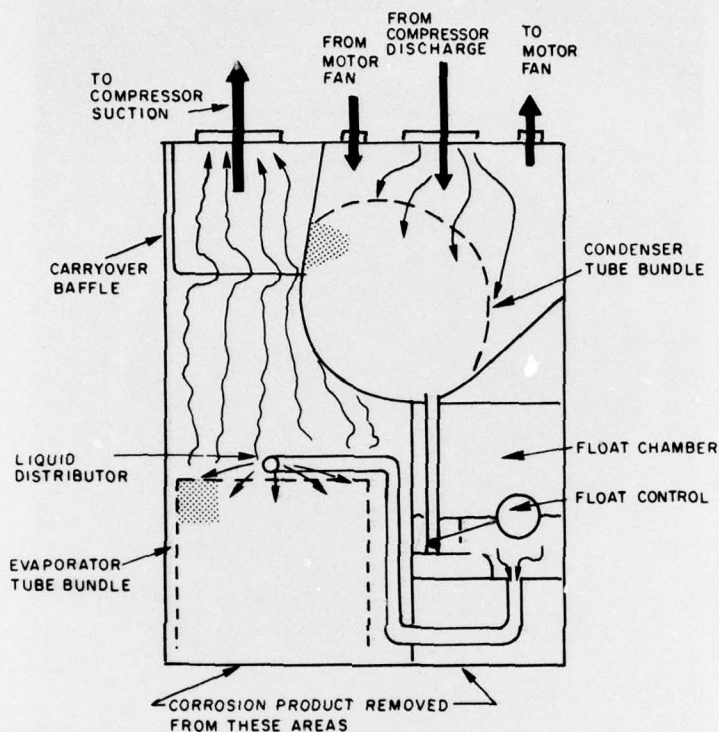
Fig. 2 — Cross section of triduty shell
